**PREDESIGN INVESTIGATION RESULTS
LANDFILL GAS AND LEACHATE
COMPONENTS**

**H.O.D. LANDFILL SITE
USEPA DOCKET NO. V-W-99-C-543**

**VILLAGE OF ANTIOCH
LAKE COUNTY, ILLINOIS**

May 2000

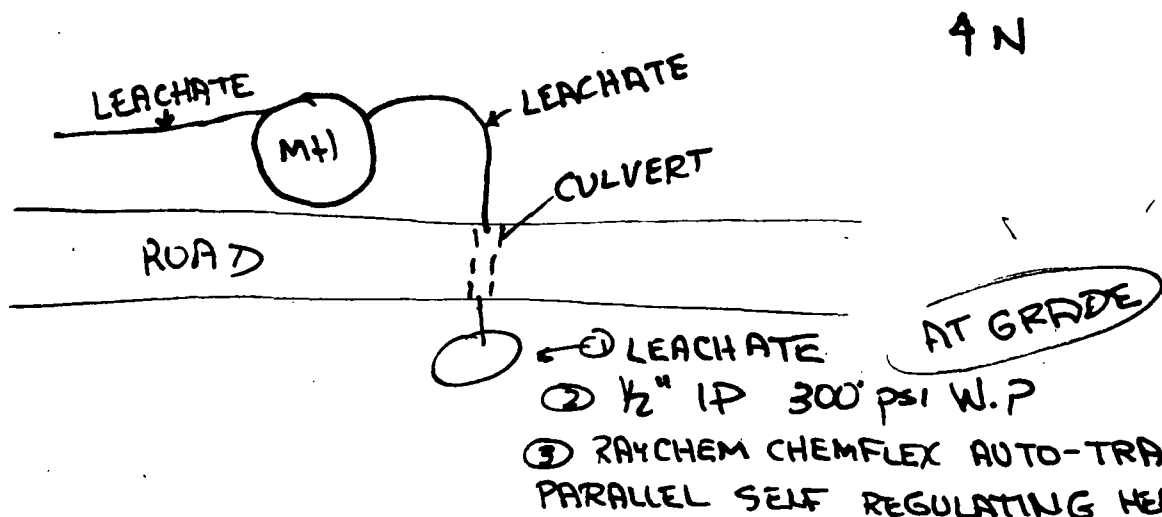
ELECTRIC LINE (?)

INSULATION HEAVILY DETERIORATED

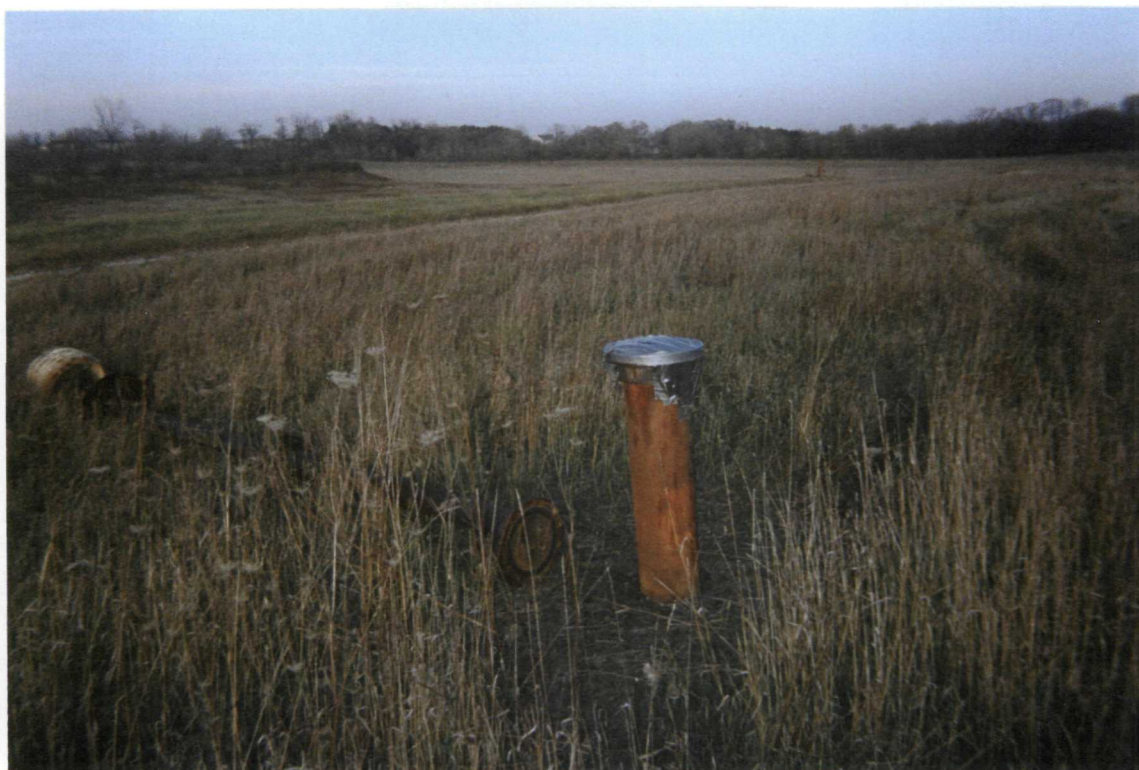
**Roll 1, Photograph 18, Facing Northeast
11/08/99 at 16:24, View of GWF 3**

13:20 → GWF 3 3' 0" TO FLARE FLANGE
POSITIVE PRESSURE, SOME CONDENSATE DRIPS,
FLARE RUSTED, FLARE BUCKET CRACKED/
BRITTLE, NOT HEAVILY CORRODED, COVER IN
GOOD CONDITION

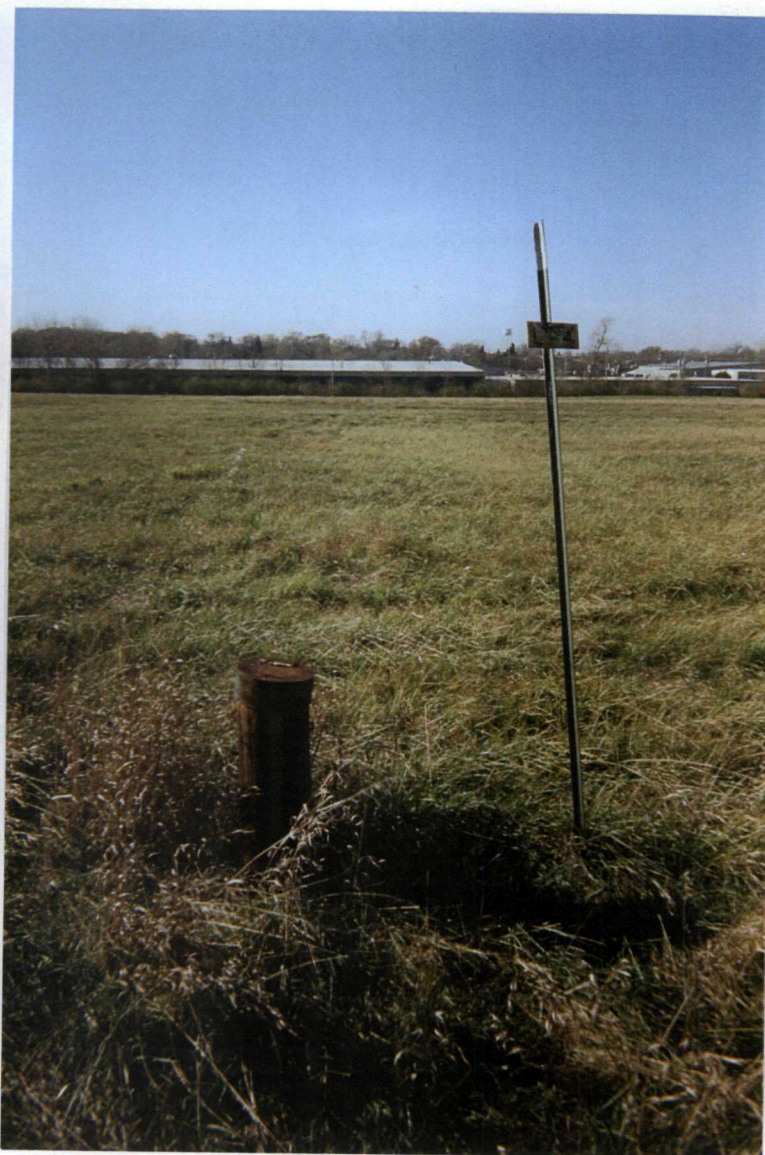
Roll 1, Photograph 6
Facing Northwest
11/08/99 at 13:05
View of LP 4

15:35 → LP 4 2'5" CASING STICKUP
- 1 1/2" TO PVC TOP (STAINED GREY)
COVER IN GOOD CONDITION
